## INSPECTION REPORT

Project Ref.: 110176TND

P.O. No. 110176TND  
QCLNG Project,Australia

Induction Bends

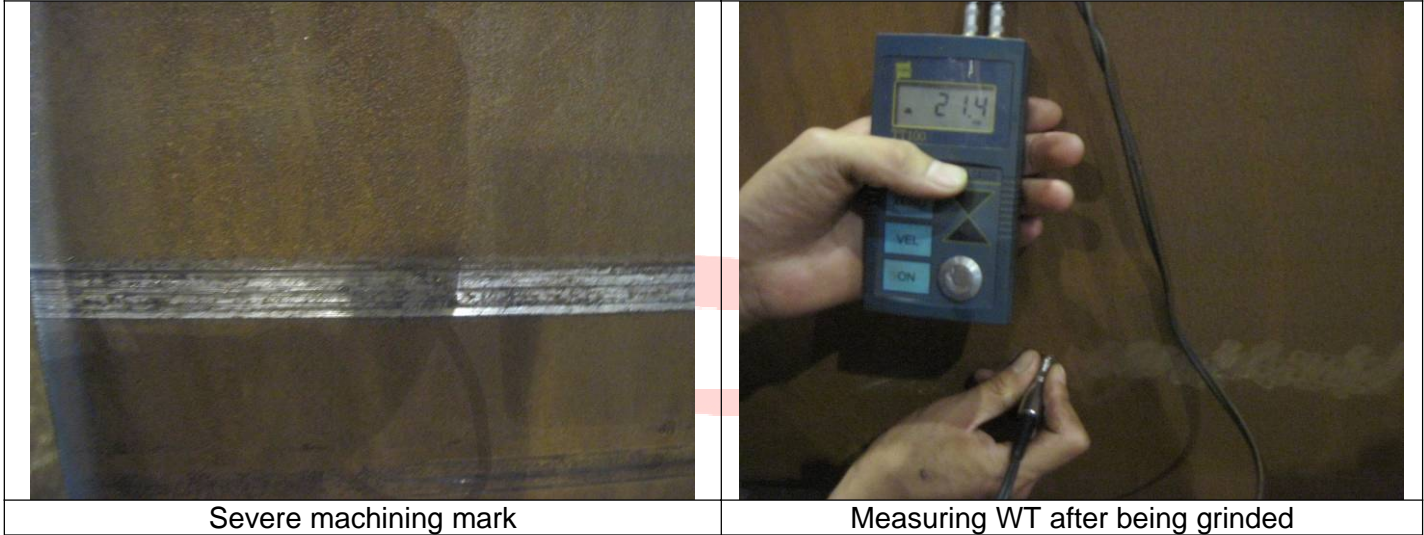
They were qualified and there was a severe machining mark on the outer surface of IND-N18, which had been grinded and WT was qualified.  
Photo attachment as below

Severe machining mark

Measuring WT after being grinded

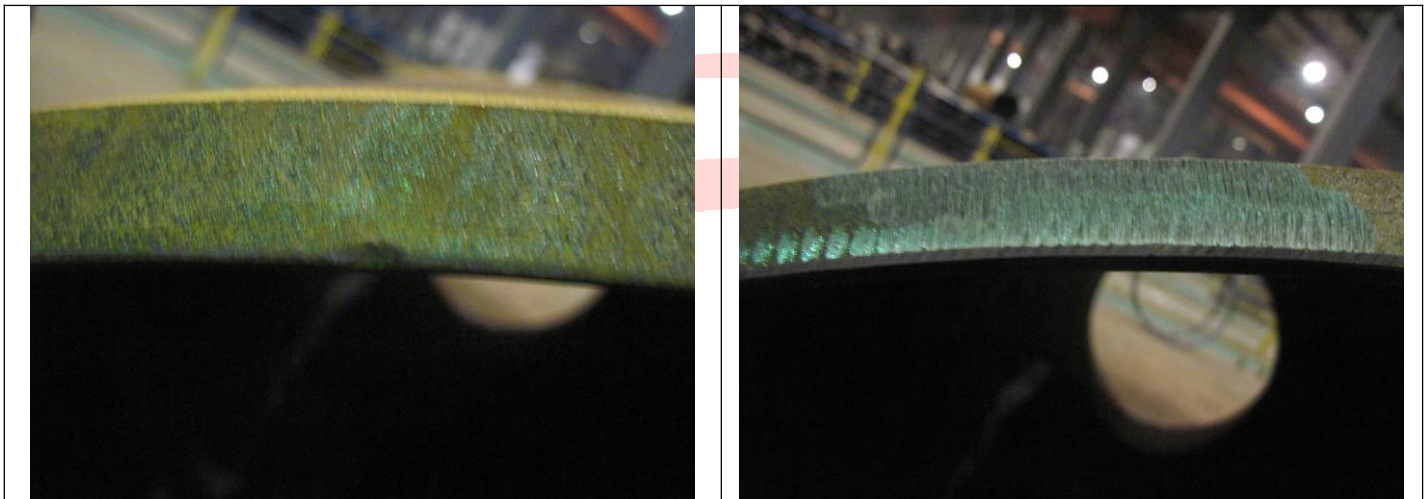
- 1) Some root faces were hurt which had been repaired;
- 2) There were some pits on the outer surface, which had been grinded and WT was qualified.

Hurt root face	After being repaired
----------------	----------------------
