INSPECTION Report No.: MIL Issued on: Mar 1 ^s Inspection Time:	92708&92708-B		P.O. No.	
Inspection				
Subject: Customer:	Seamless Tubes			
Address:				
Specification:	ASTM A179	Inspector:	Lin Gaojie	Stamp No:
Visit Summary: Scope of Inspection - Visual inspection. - Dimension inspection. - Packaging and quantity inspection. - Documents review. - Part photo service.

Results of inspection to MIL 92708&92708-B

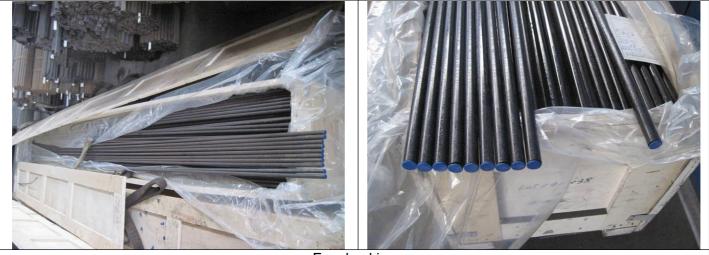
The tubes were good except a little rust on the surface, and the details were as followed:

- 1) Tube ends had squared cut and deburred well;
- 2) One case of tubes were varnished.

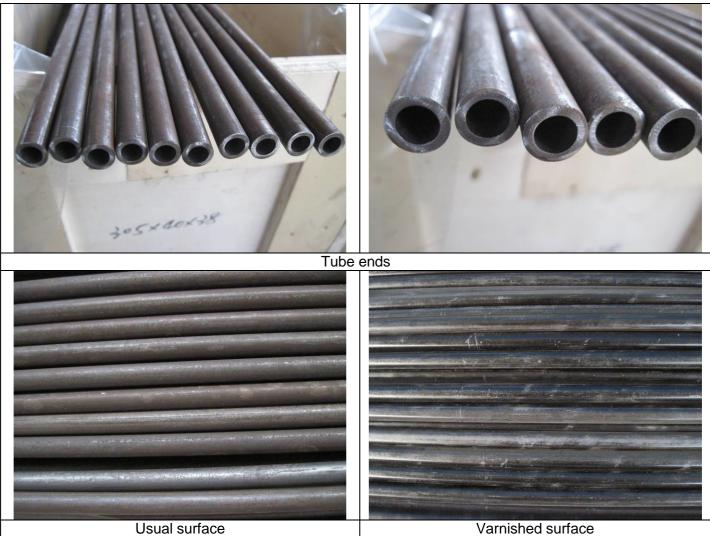
Varnished surface

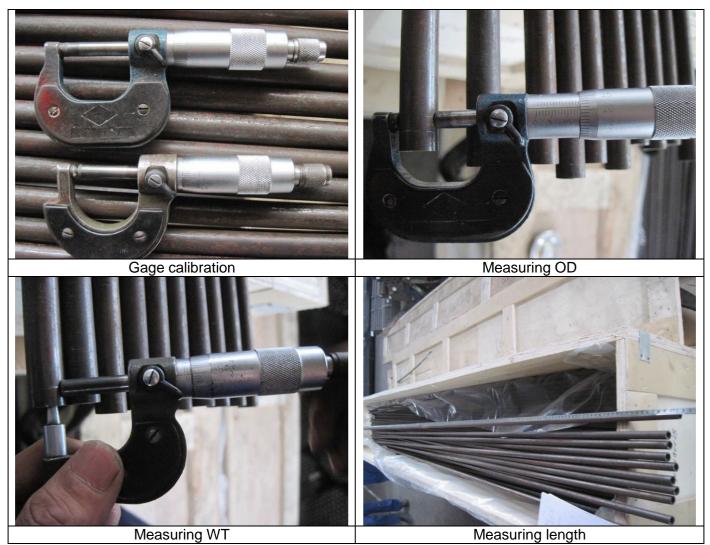
We had measured the pipe dimensions and they were all qualified. The detailed data is in the following table.

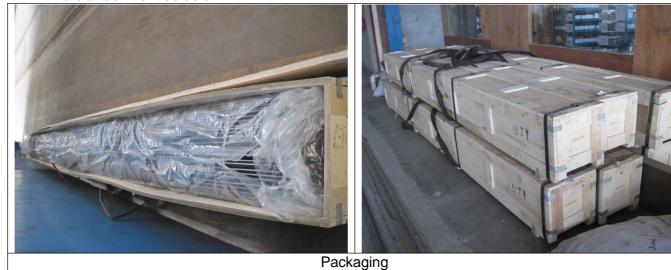
- 3. Packaging and quantity inspection1) The tubes were put into the plywood case with poly bag after being stuffed with caps;
- 2) The quantity was right. Photo attachment as below
