## INSPECTION REPORT

Report No.: MIL G2NG-5-0001-01

Inspection	SMLS Pipes			
Purchaser:	Santos (Australia) Pty Ltd.			
Specification:	API 5L 44 <sup>th</sup> Edition Gr.B / ASTM A106 Gr. B	Inspector:	Lin Gaojie	Stamp No:

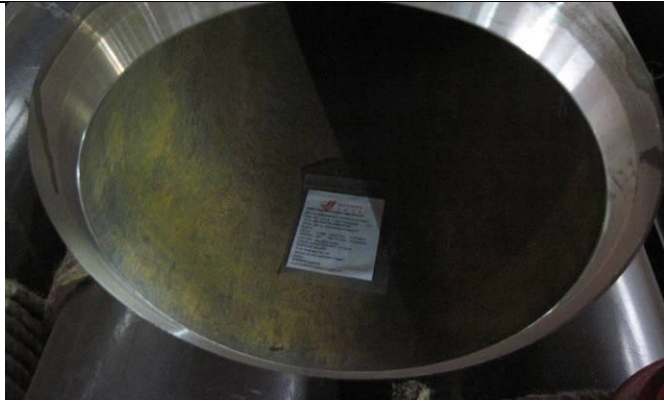
Bevel end in accordance with ASME B16.25, fig.

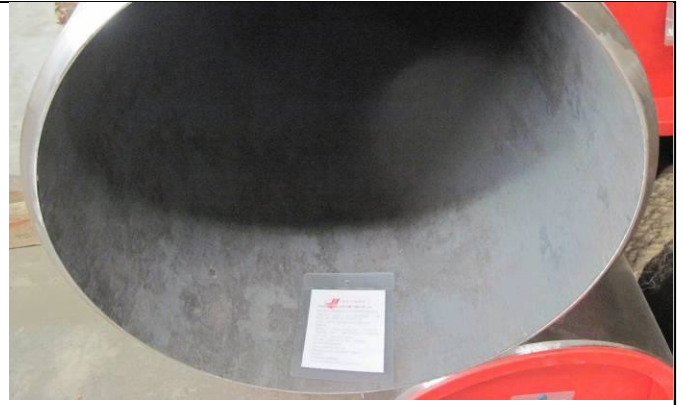
Bevel end in accordance with ASME B16.25, fig.

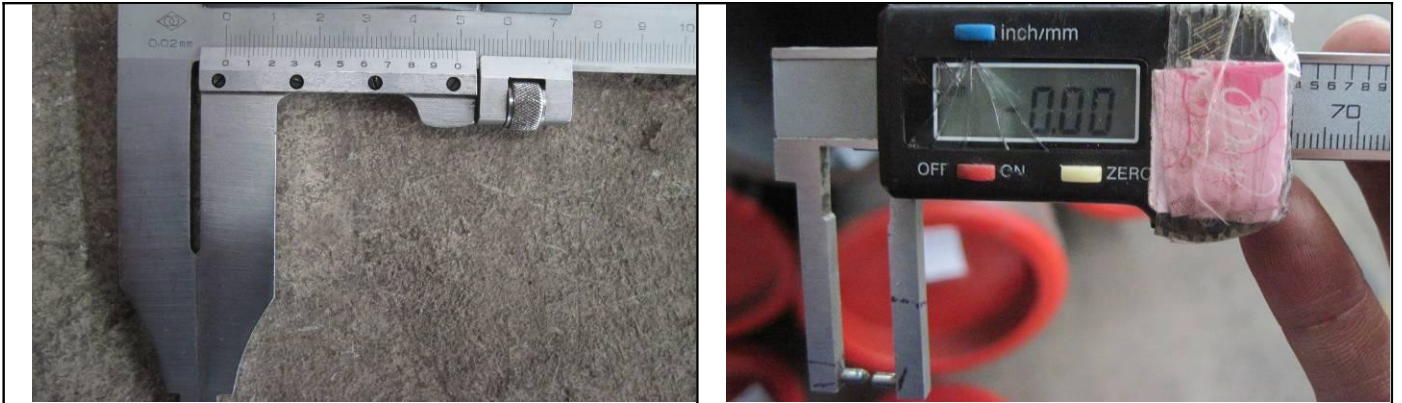
Gage calibration

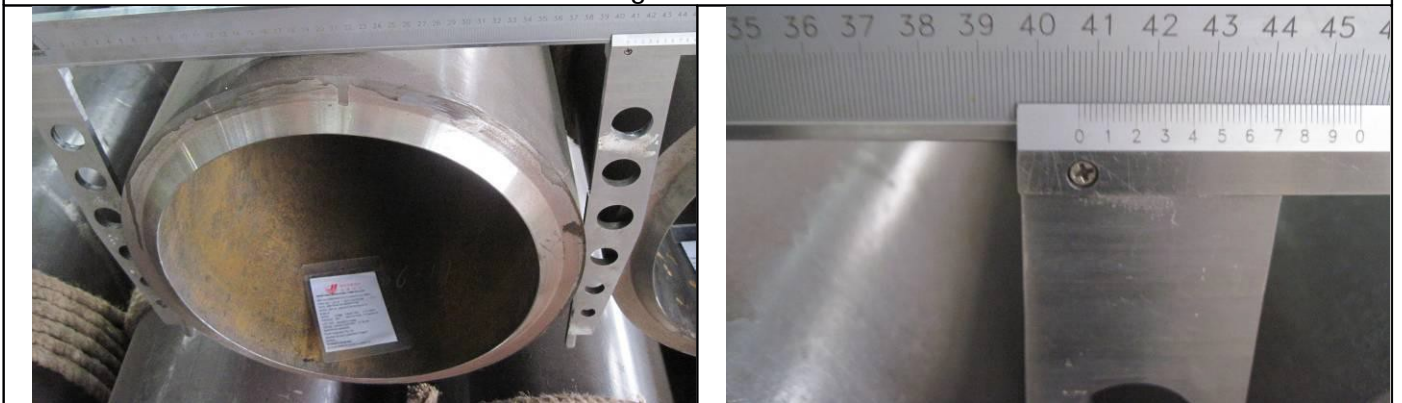
Measuring OD

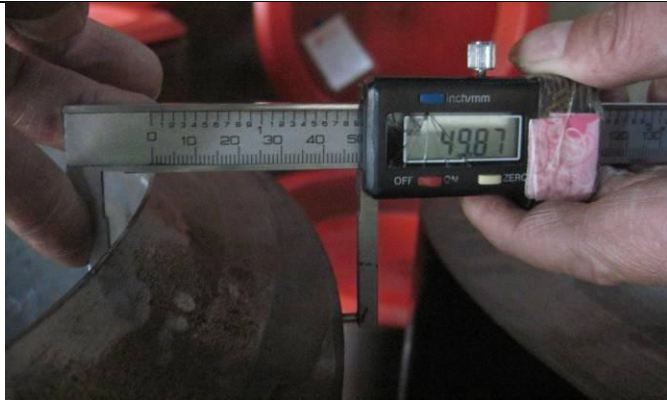
Measuring WT

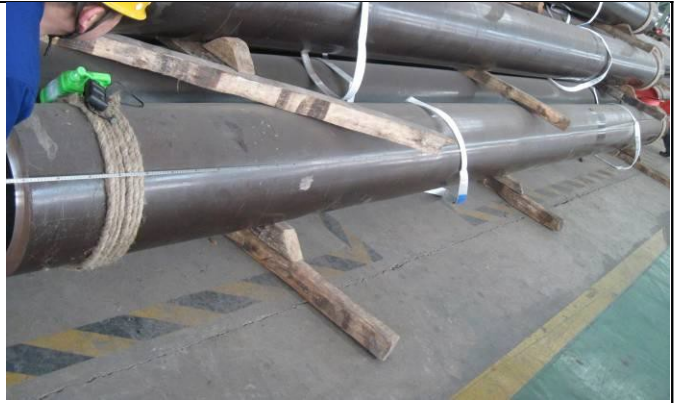
Measuring length

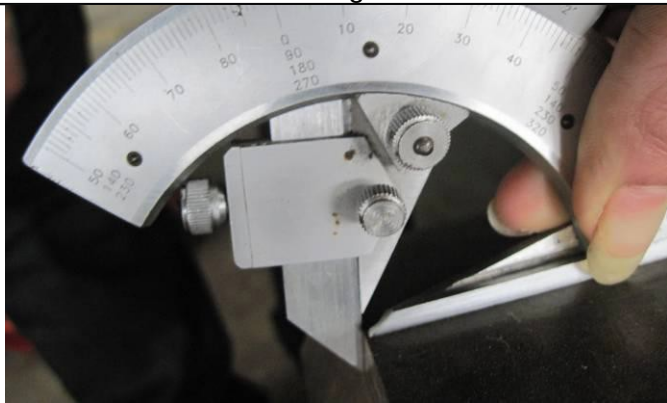
Measuring bevel angle in accordance with ASME B16.25, fig. 3a

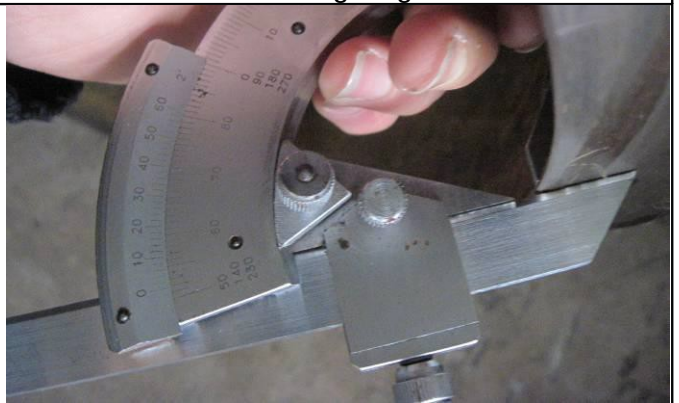
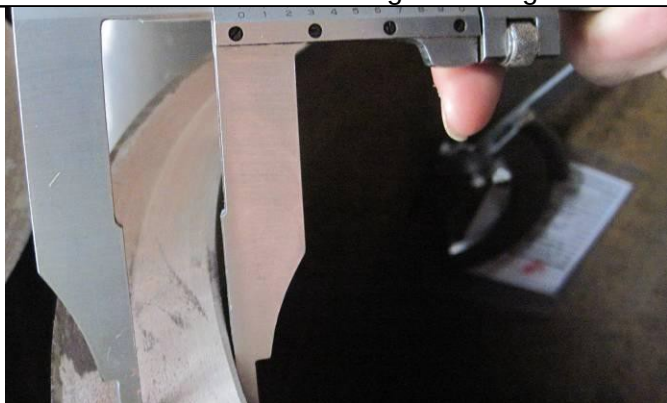
Measuring height of bevel angle and root face in accordance with ASME B16.25, fig. 3a
