Inspection Order No. : IN-SH-PSI-09351
Page No. : 1 OF 10
Date of issue: Dec.03, 2009

INSPECTION REPORT
(non-negotiable)

- Description and Quantity of Commodity: OCTG SEAMLESS API 5-CT N80 R3 BTC
13 3/8" x 61ppf 2000m/181.536MT

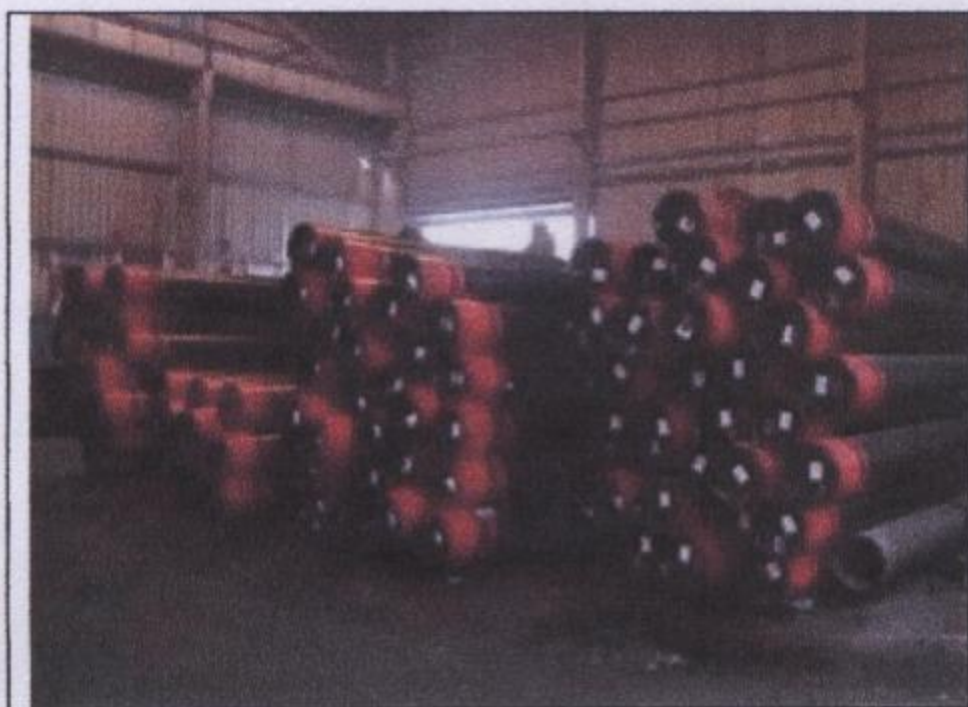
1. pipes in the mill warehouse

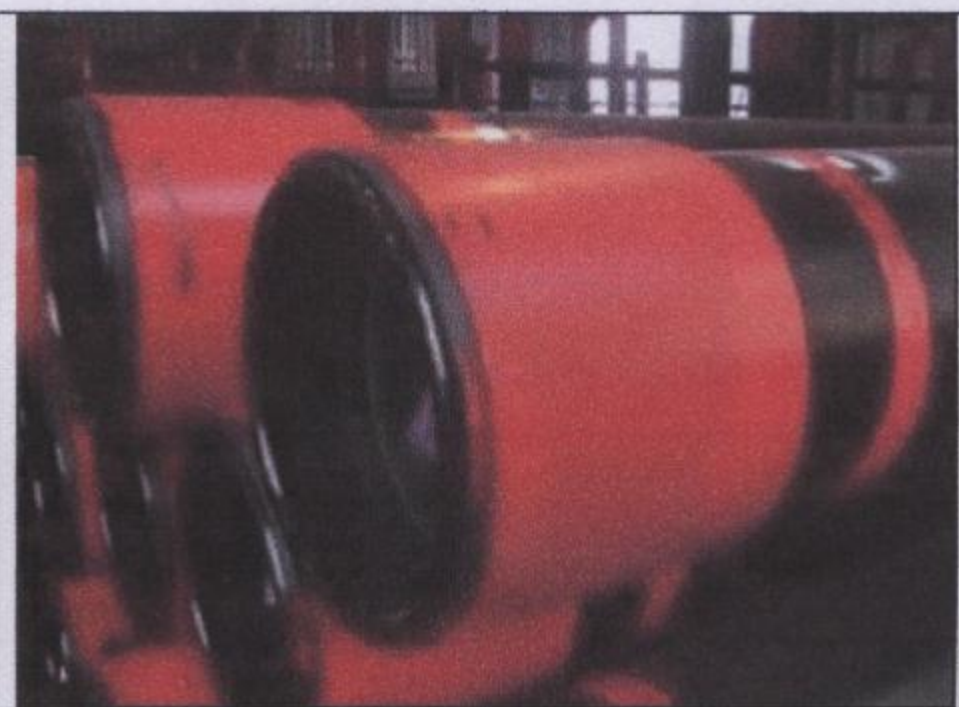
2. pipe coupling red ring

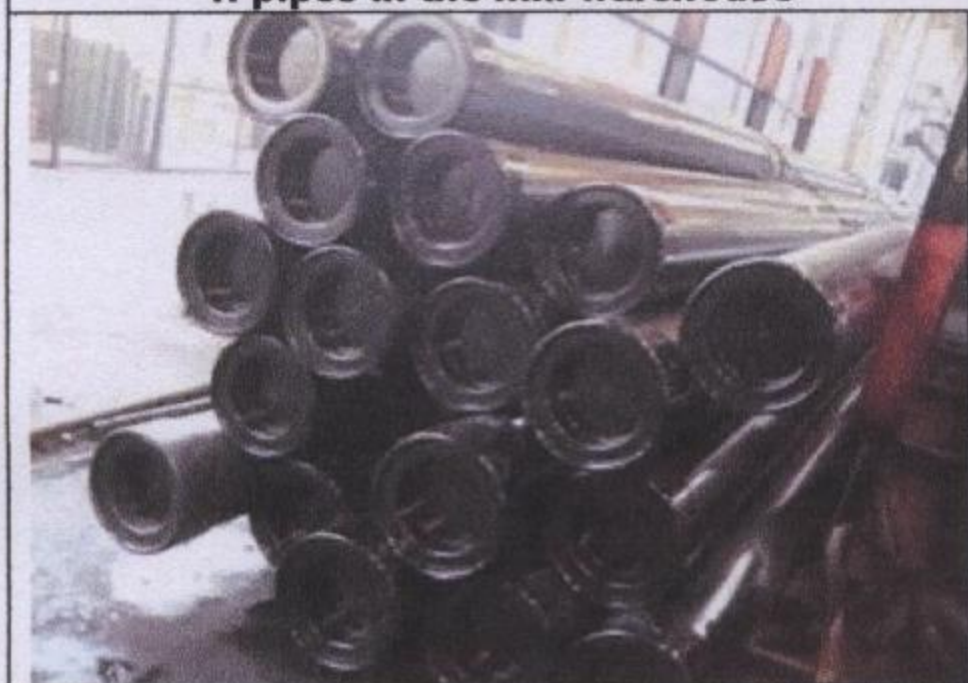
3. pipe end

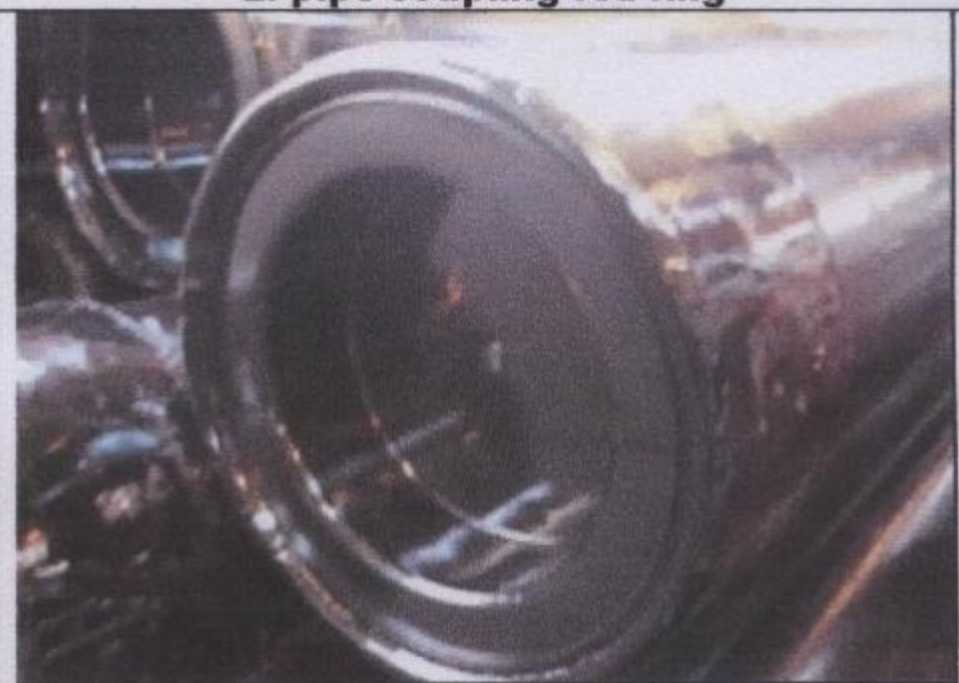
4. pipe end thread protector

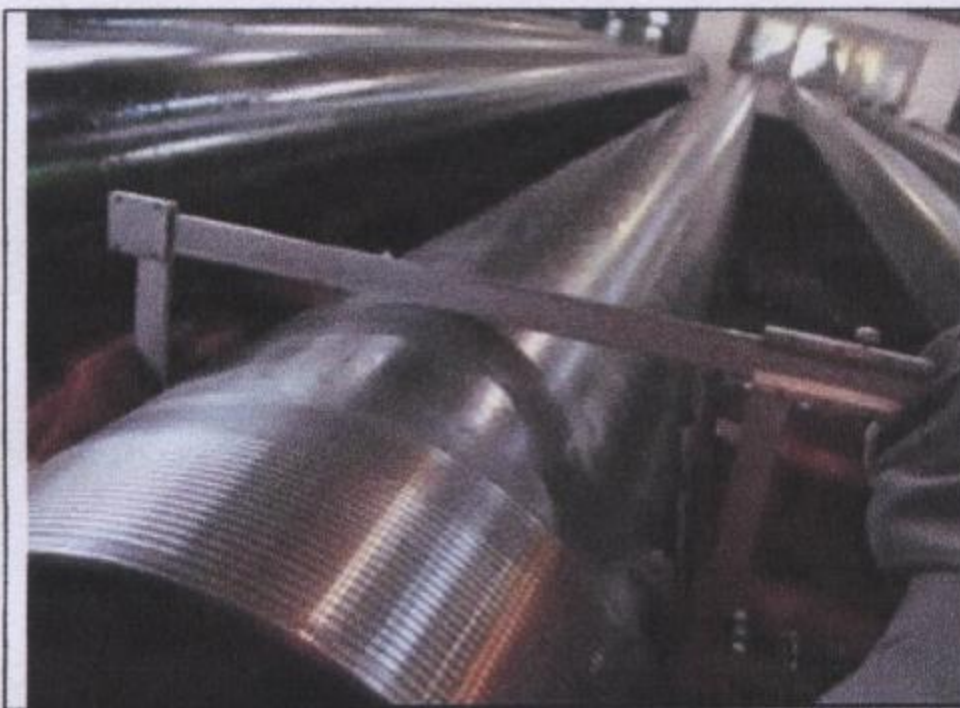
11. pipe body O.D check

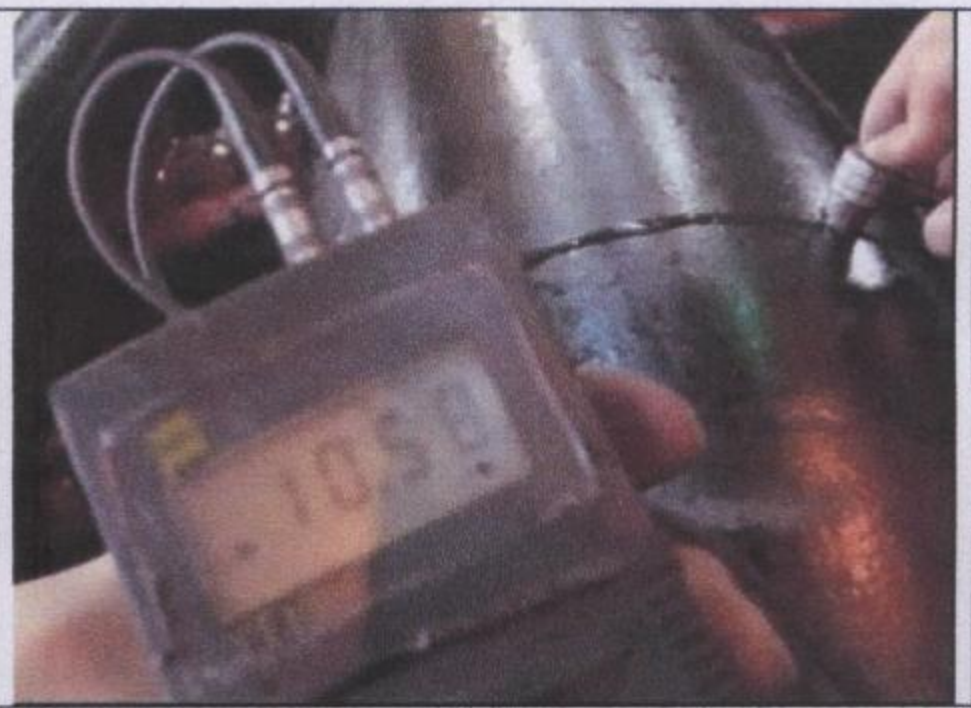
12. pipe W.T check

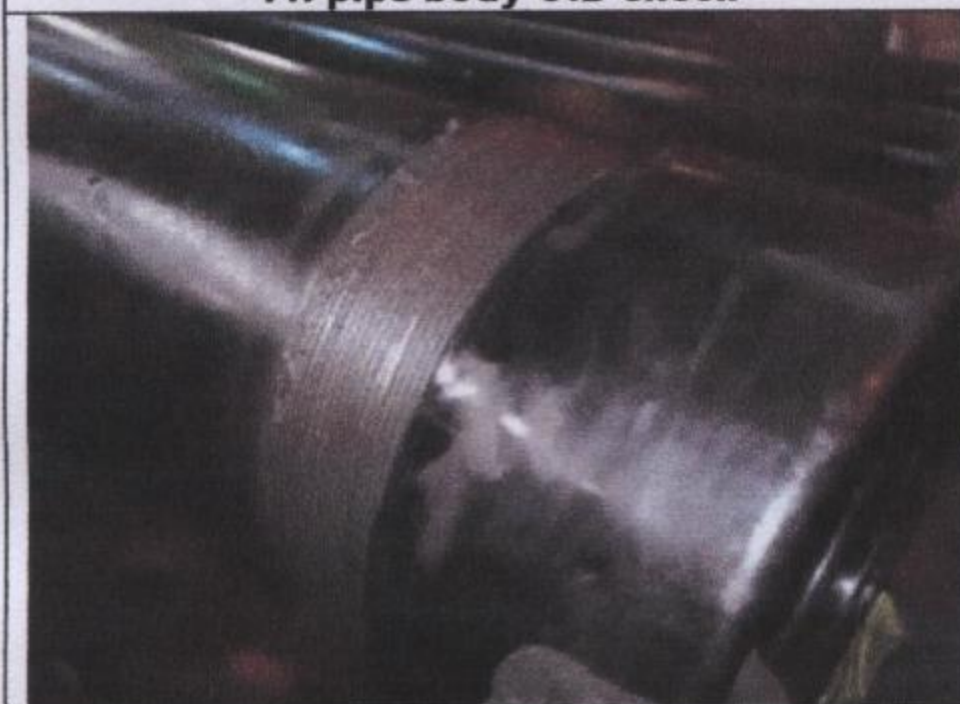
13. thread check

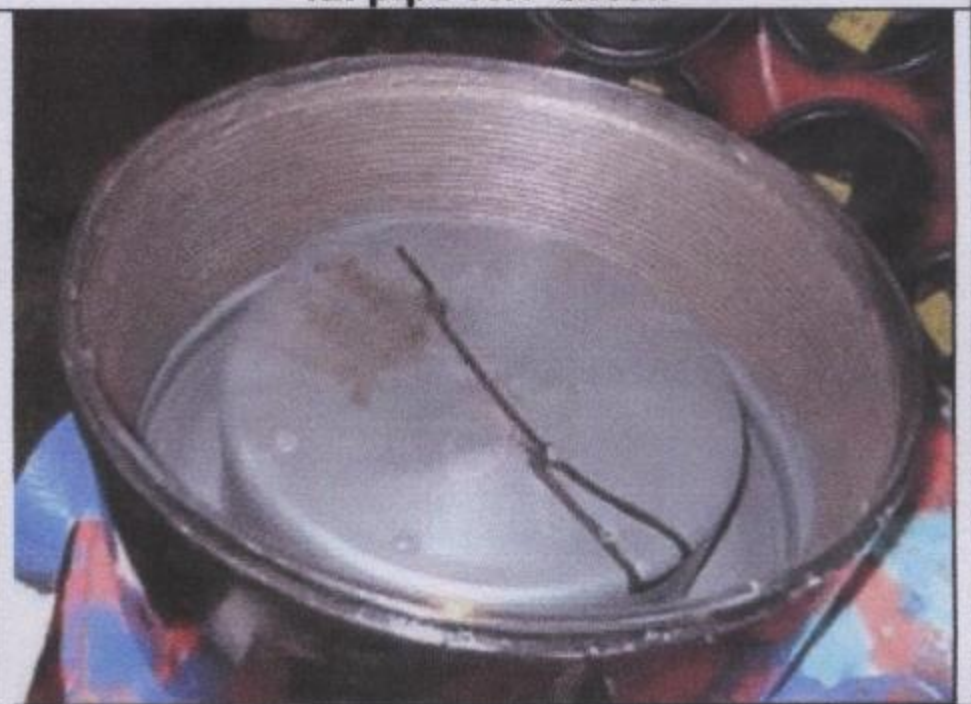
14. thread protector

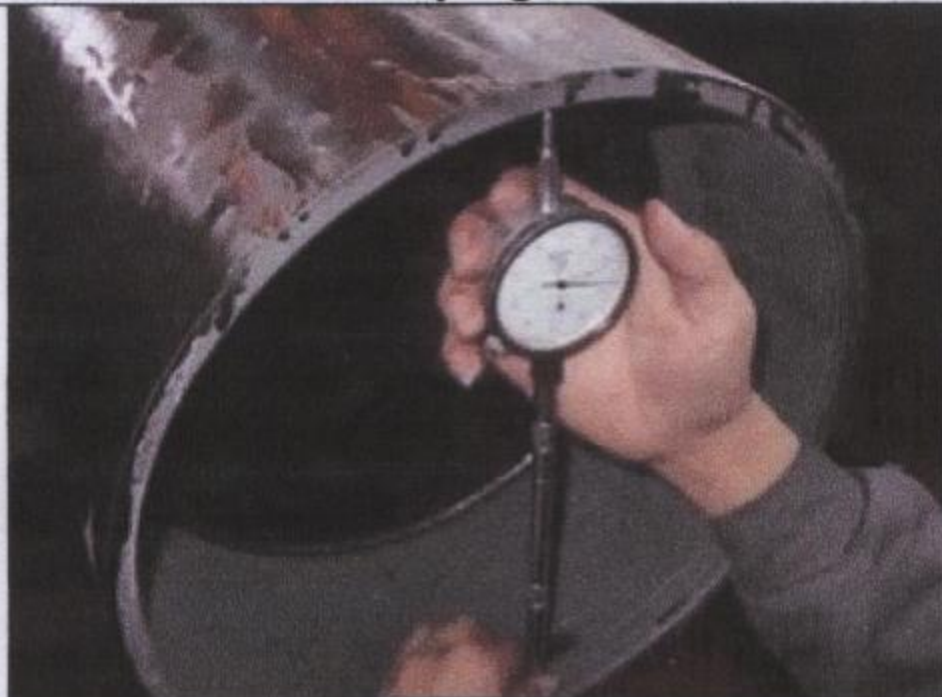
<p>22. coupling check</p>

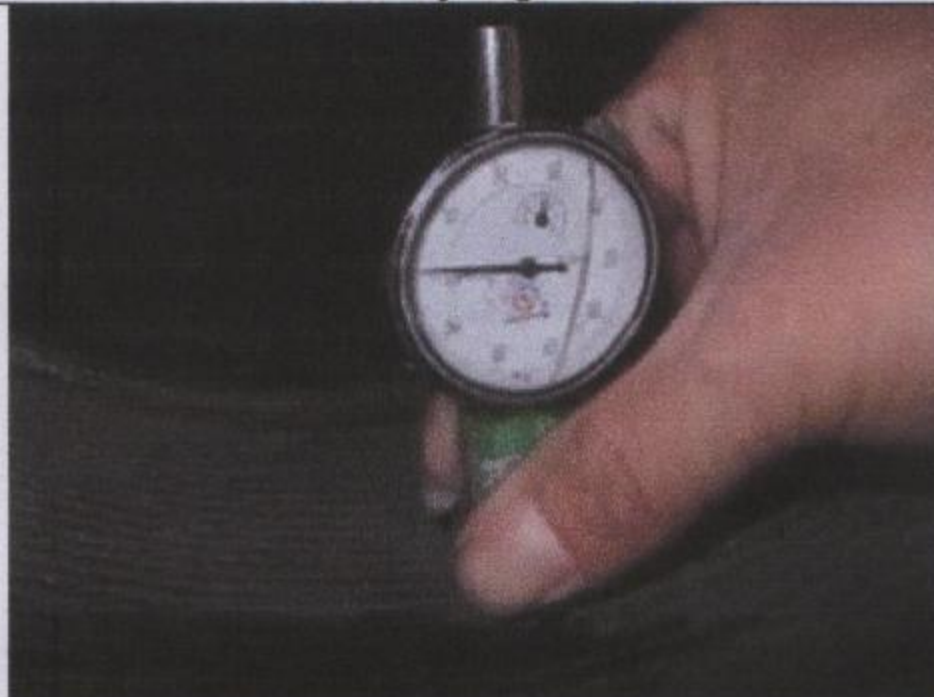
<p>23. pitch of female thread check</p>

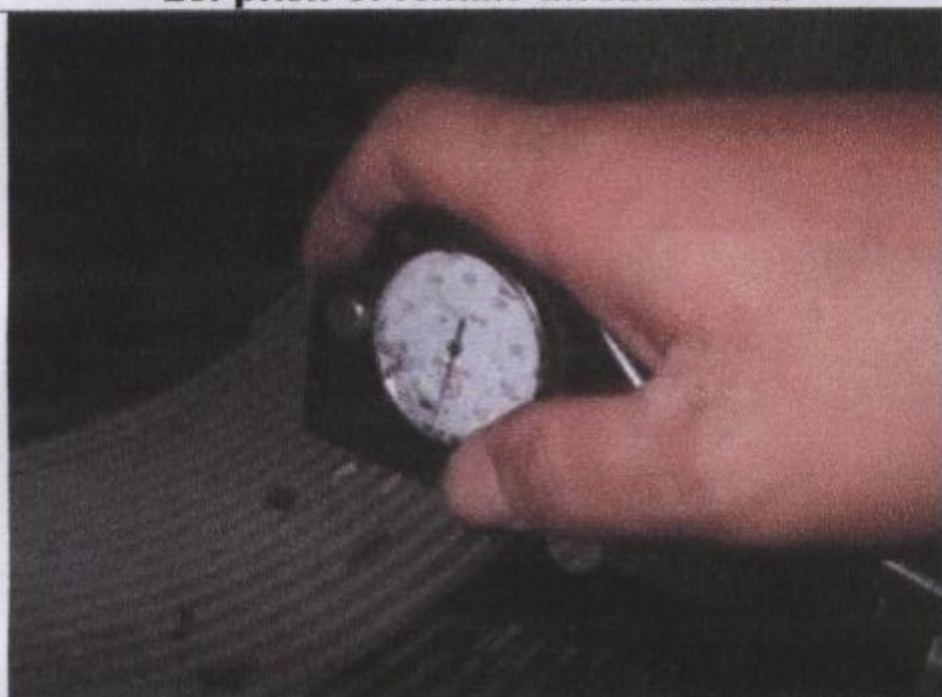
<p>24. tooth depth of female thread check</p>

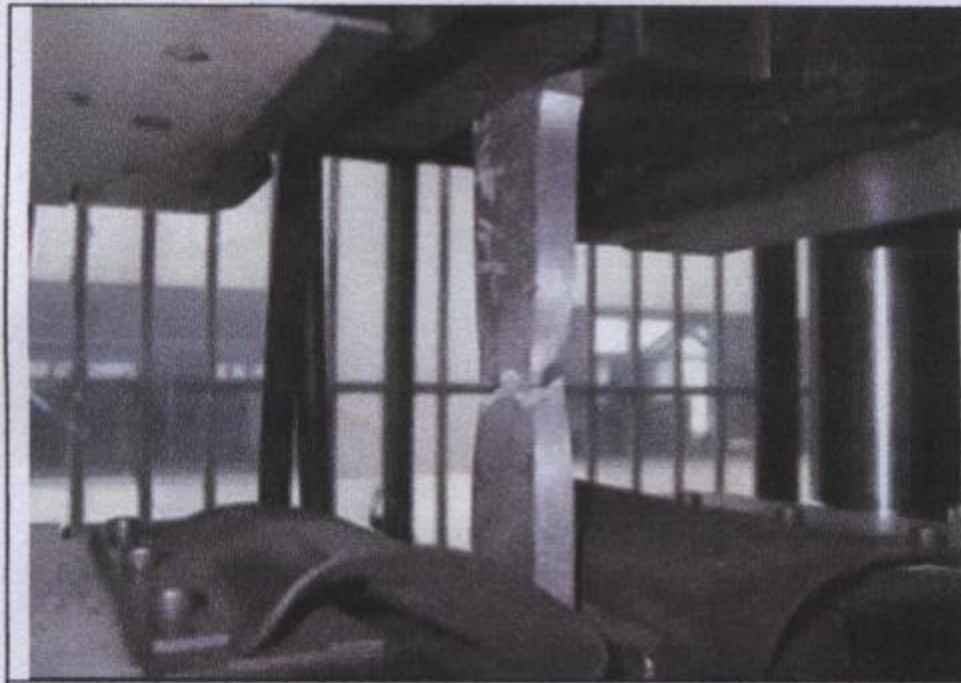
27. tensile strength test

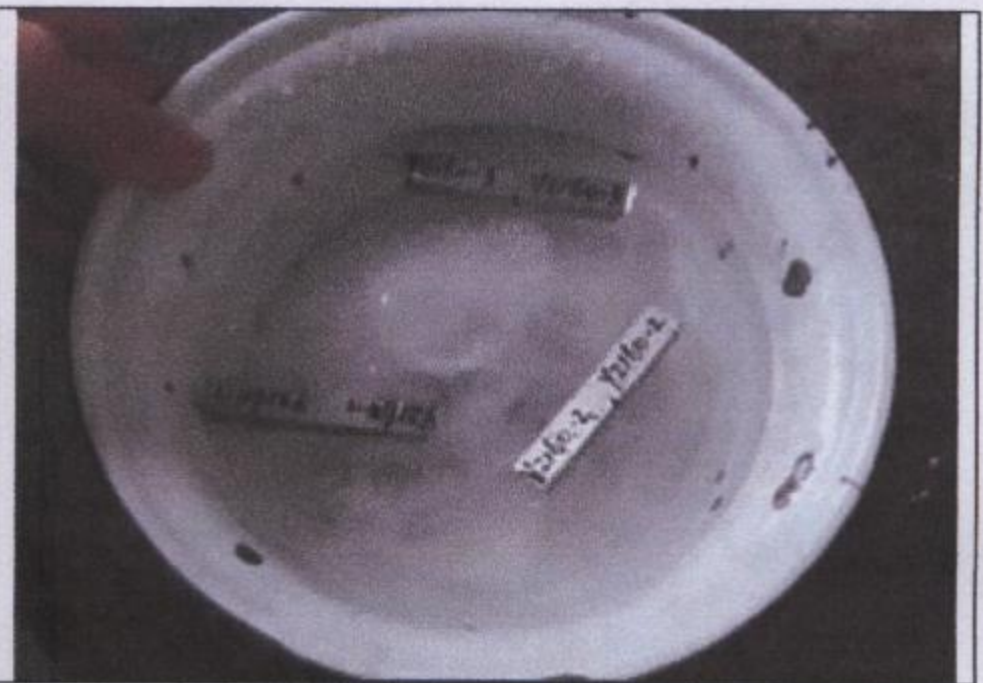
28. sample 0°C

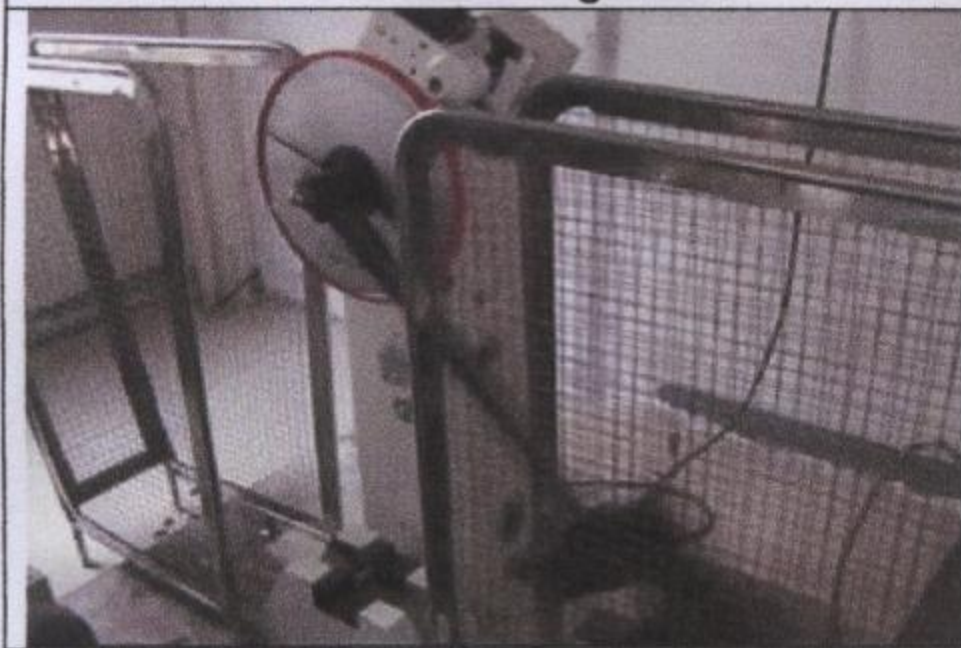
29. impact test 0°C

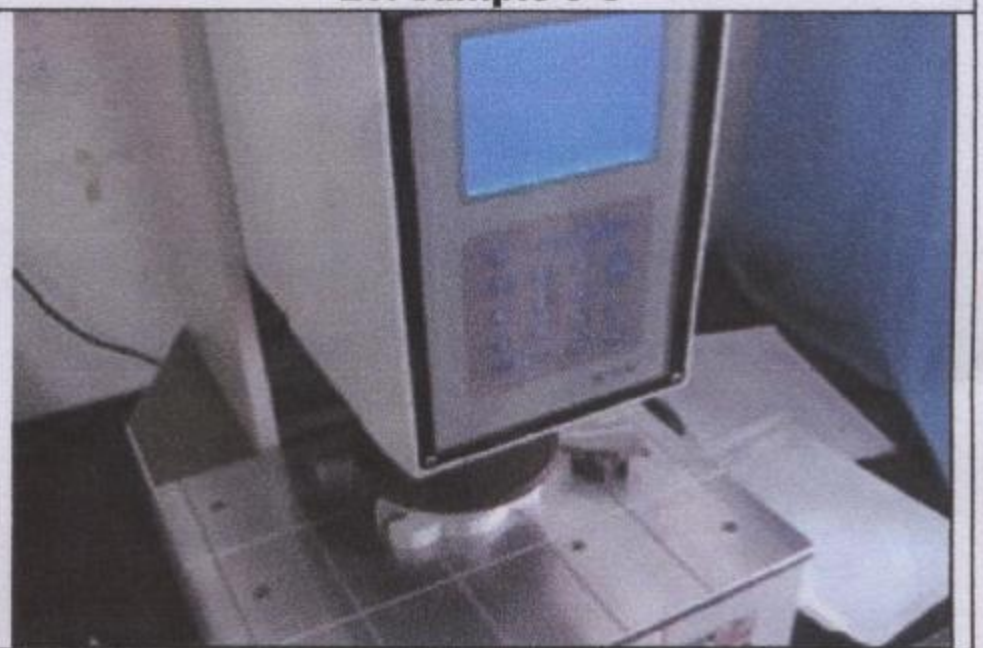
30. hardness test

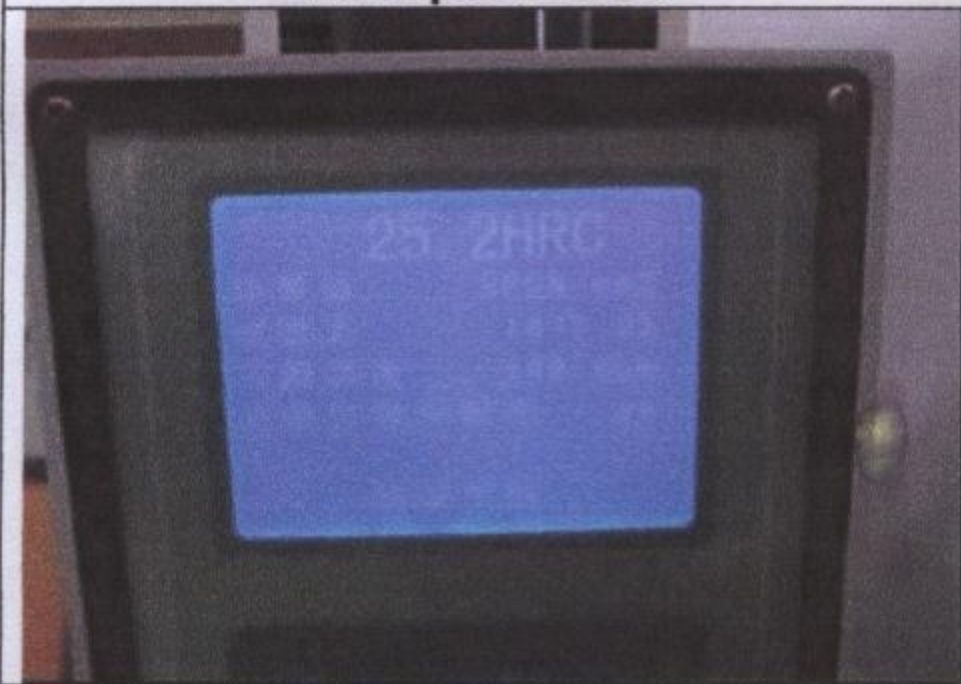
31. HRC 25.2
