INSPECTION REPORT

Report No.: ABTER161207

Inspection Subject: Seamless Stainless Steel Tube

Specification: ASTM A269 TP316/316L

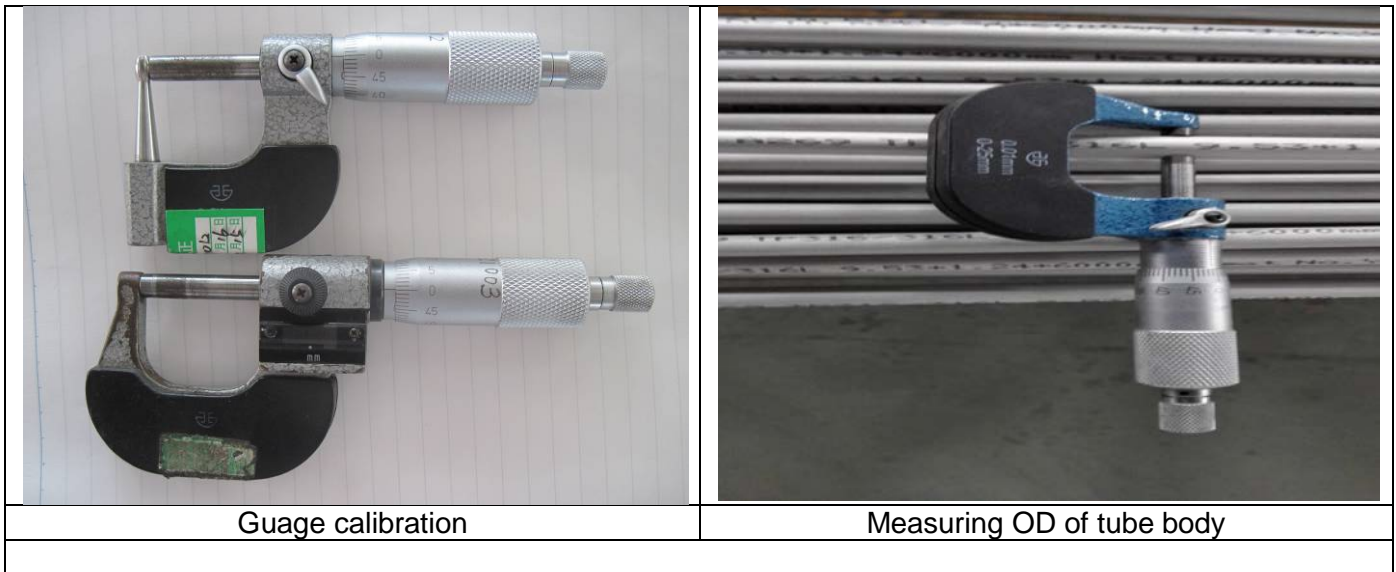
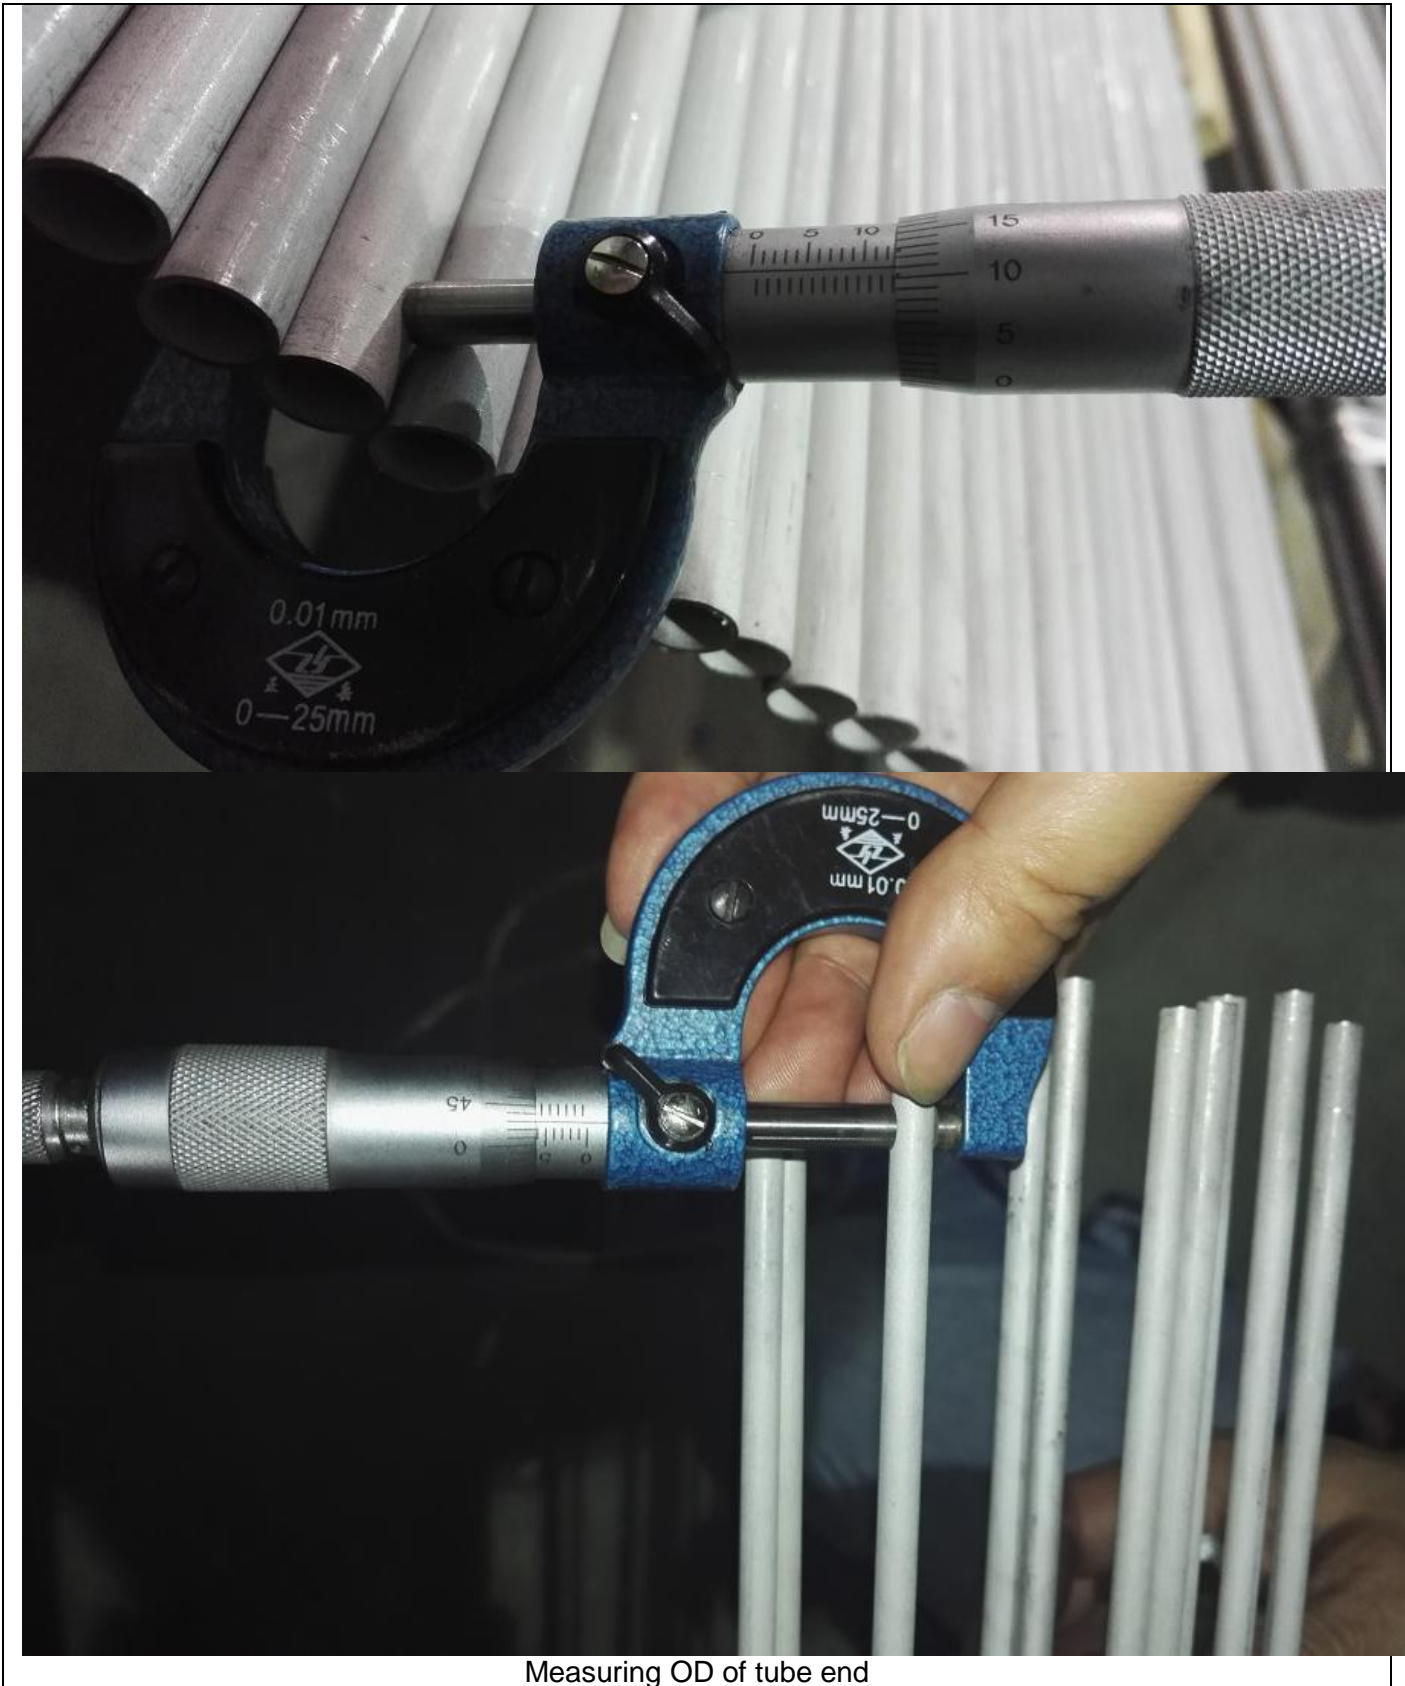
The tubes were polished well and the tube ends have squared cut and deburred.

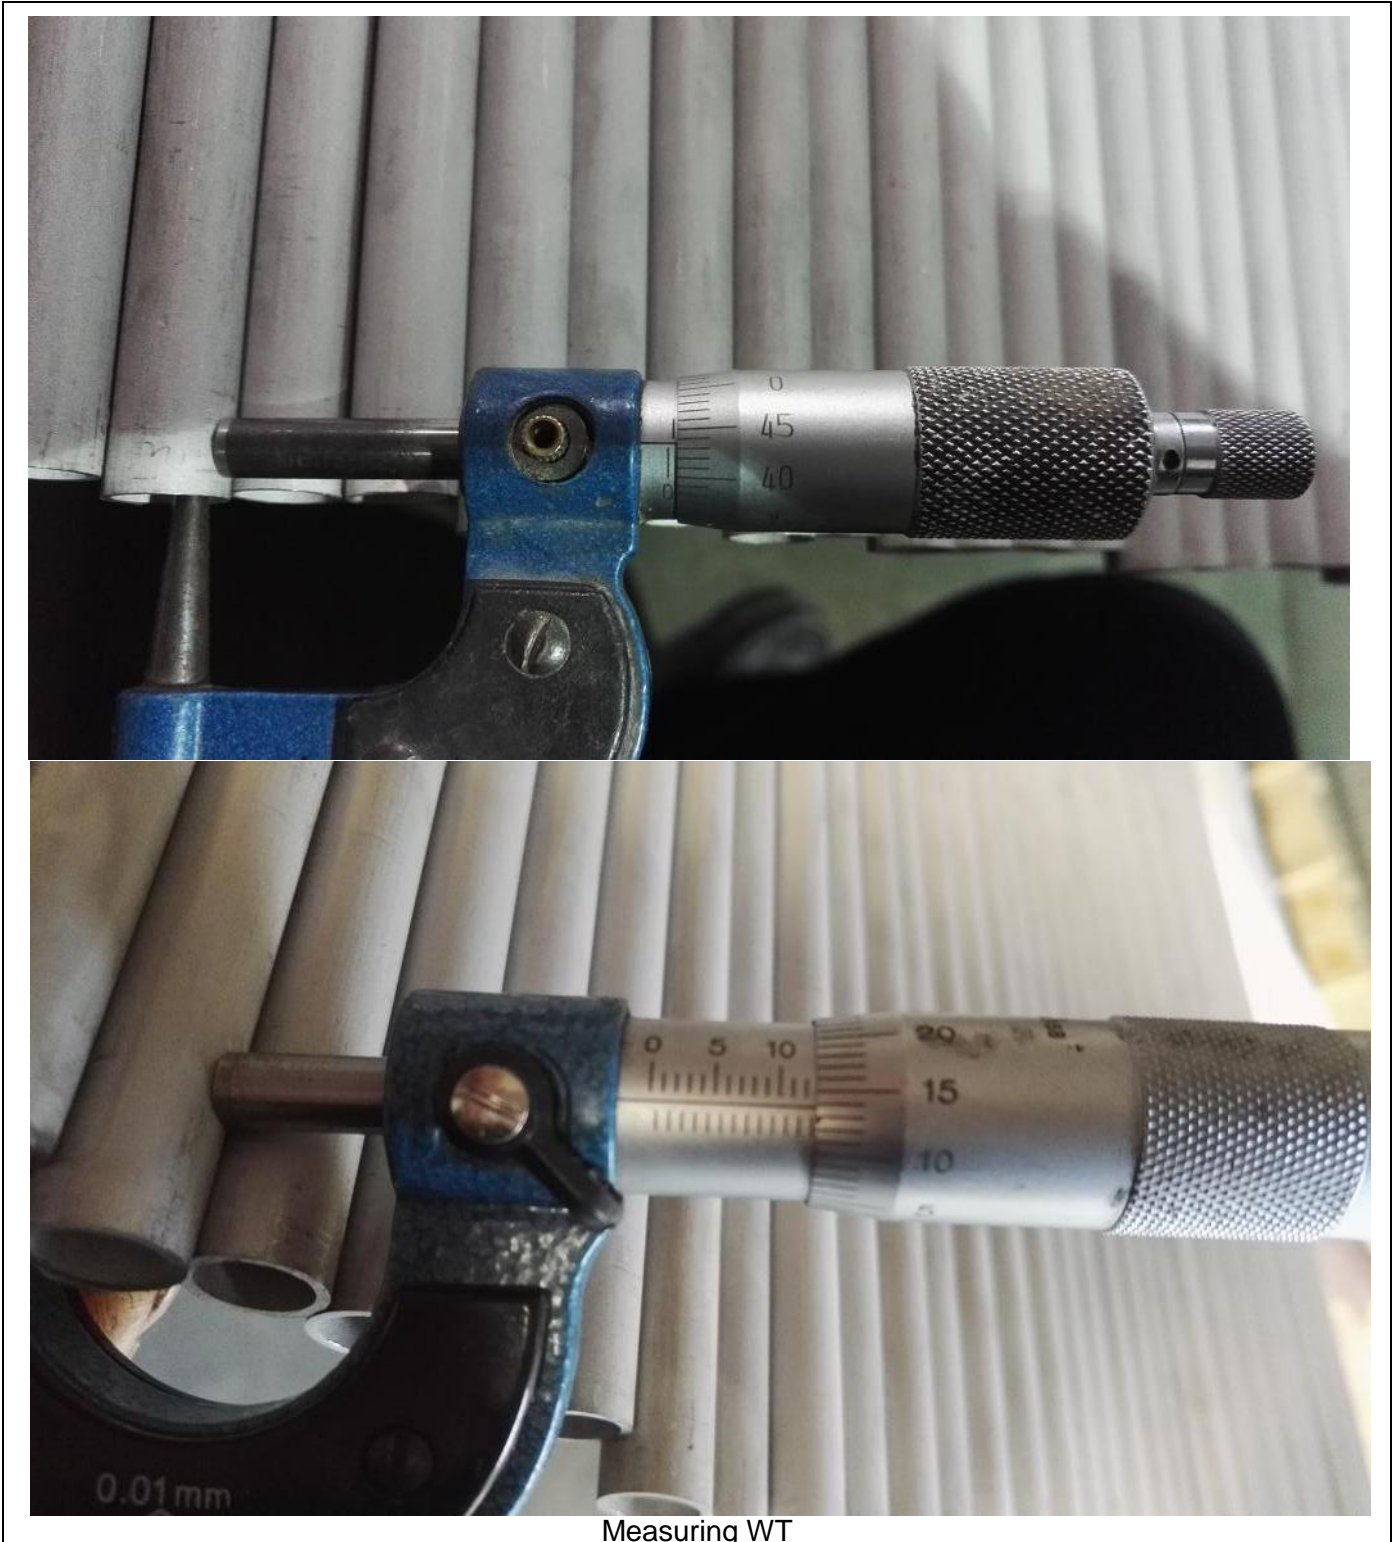
We had measured tube dimensions randomly and they were all qualified. The detailed data is in the following table.

Measuring OD of tube end

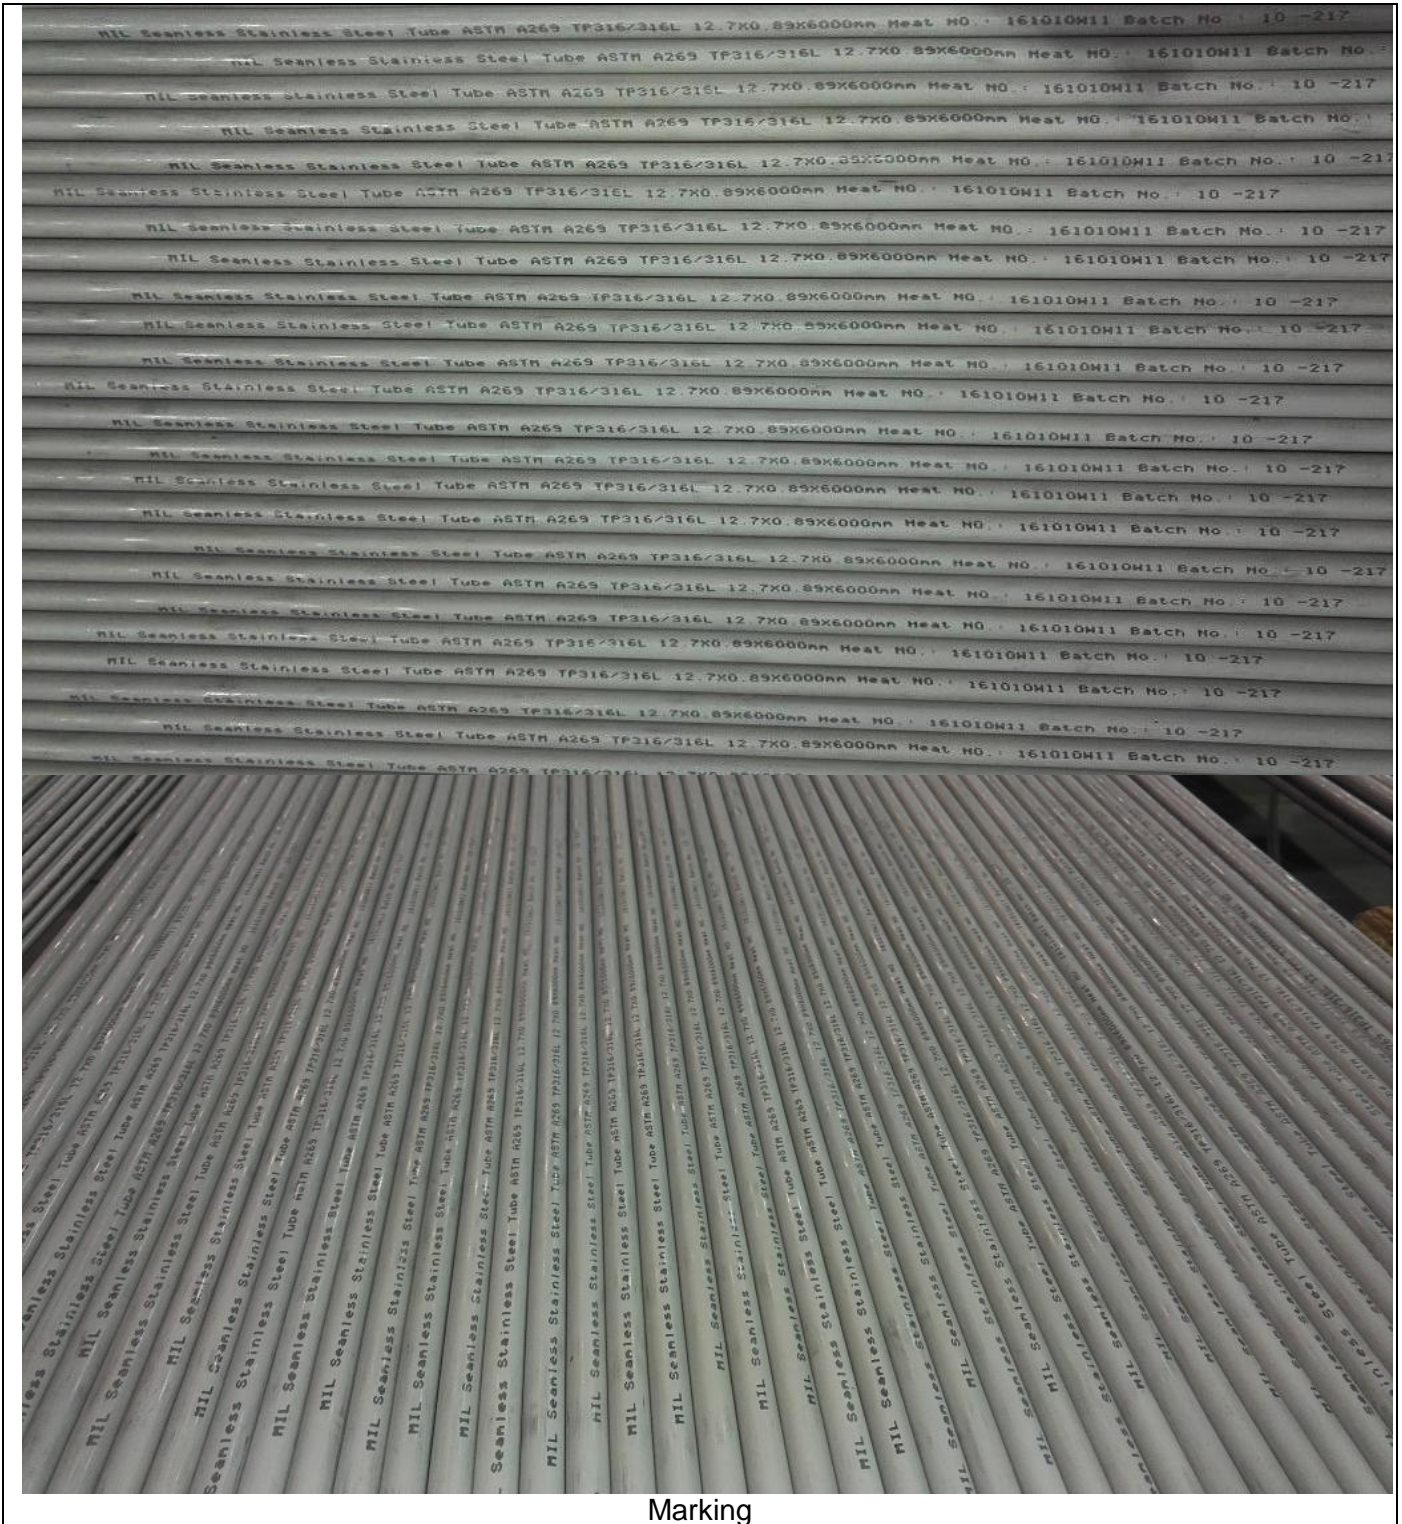
The tubes were plugged with blue covers on both ends first, then bundled by the poly bags and put into plywood case. The quantity and marking were right. Details as below:

Marking

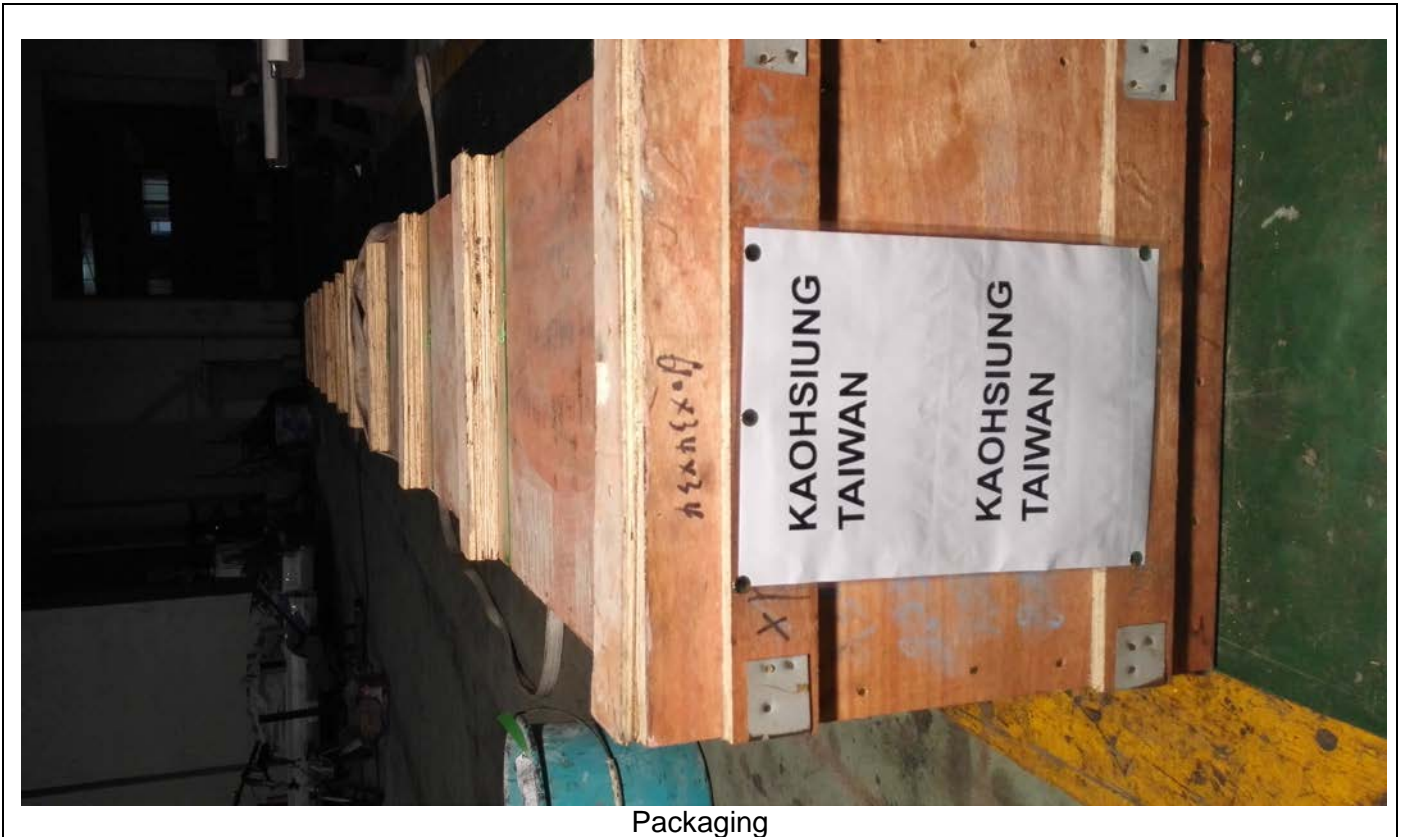
Packaging
