## INSPECTION REPORT

Project Ref.: 110176TND

P.O. No. 110176TND  
QCLNG Project,Australia

Induction Bends

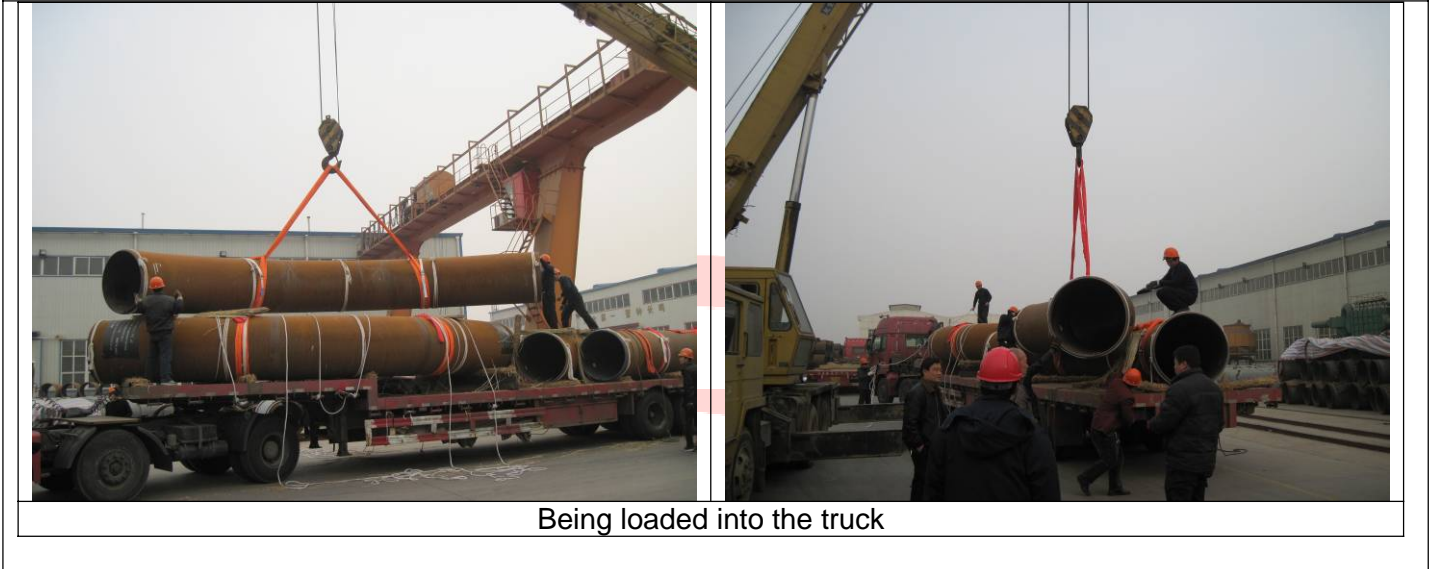
- 4) The quantity was right;
- 5) The new labels were right and there were 6 labels inside of each bend( 3 ones each end);
- 6) The old polyester slings(safety factor: 6:1) had been replaced by new ones(safety factor: 8:1).  
Photo attachment as below
